**NSWCCD-65-TR-2003/37** September 2003

## **SIDER Testing of Royal Navy Vessel P292 HMS *Trumpeter***

SUBJ: STRUCTURAL IRREGULARITY AND DAMAGE EVALUATION ROUTINE  
(SIDER) INSPECTION OF SHIP STRUCTURES

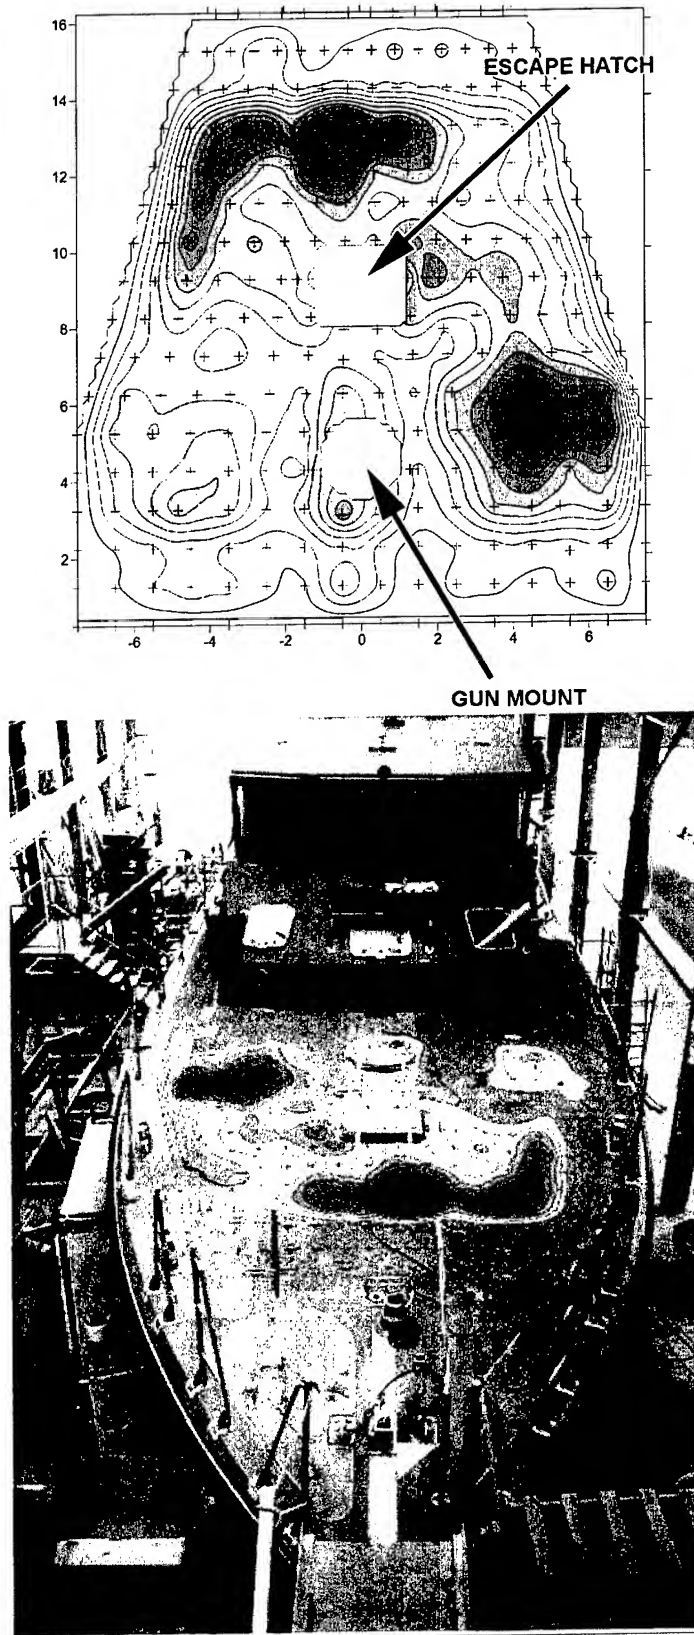
Figure 7. SIDER Fore-Aft Analysis

Figure 7 and Figure 8 show the SIDER contour plots. On these plots the small crosses show the test grid and the axes legends show the distance in feet from the global origin. The SIDER is a directional test. Thus there are two results, one for the fore/aft analysis and one for the port/starboard analysis. Each result is shown as a contour plot, and separately overlayed on a photograph of the foredeck. Note that the contour plots can be used to accurately locate features, whereas the foreshortening of the photographs means that features can be shown up to a foot or more from their actual position on the photographs.

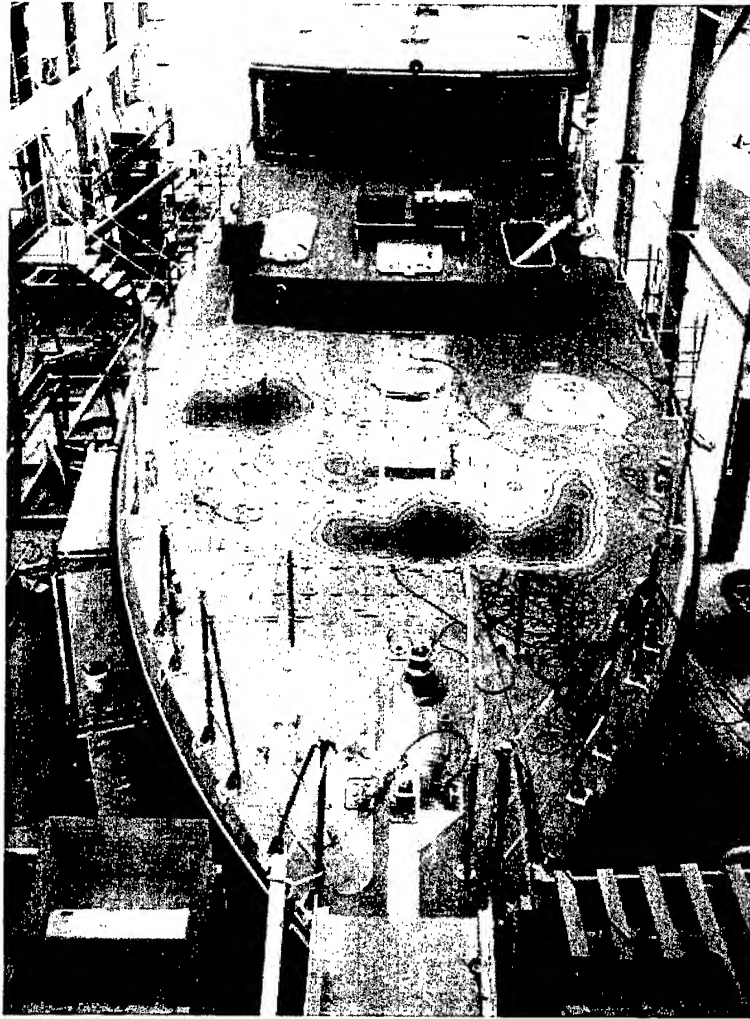
**Figure 9. Fore-Aft Analysis with Identified Features**

Figure 9 repeats Figure 7, but with two features highlighted. Feature 1 is coincident with a structural bulkhead that runs from the starboard side to the gun mount. The bulkhead does not continue to the port side. SIDER has located the stiffness change caused by this bulkhead.

Feature 2 has a maximum at the marked position, but it also extends along a port-starboard line. Just forward of this feature is a significant structural bulkhead that is almost coincident with the forward edge of the test mesh. SIDER has located the stiffness change (reduction) caused by the transition from the stiff area to the main foredeck.

Feature 6 is a major non-symmetric feature. This feature maps exactly to the lack of bulkhead mentioned in the fore-aft analysis (feature 1). Feature 1 is also coincident with a section where the nonskid surface was not bonded to the substrate, as shown in Figure 11. It is surprising to the authors that SIDER was able to locate this type of problem. The technique typically identifies regions where there are stiffness variations. The reduction in stiffness that the debonded nonskid would result in is assumed to be less than the sensitivity of the detection technique. Physical manipulation of the area, however, did reveal the soft spot that corresponded to the debonded region.

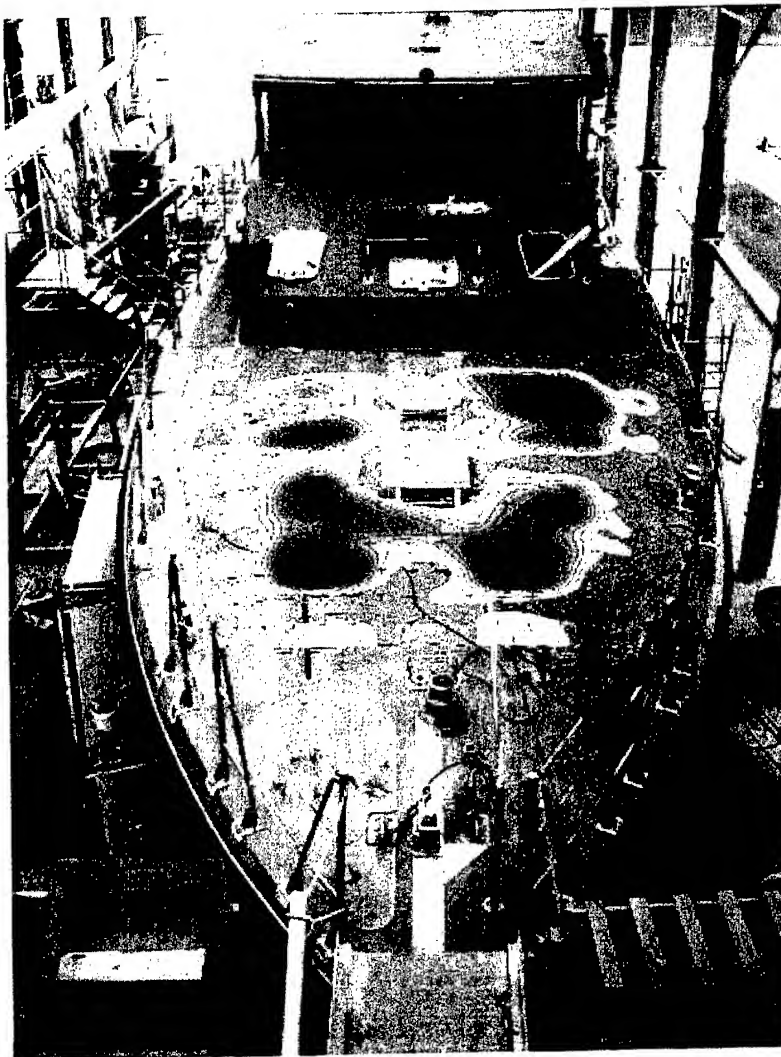
**Figure 10. Port-Starboard Analysis with Identified Features**

Figure 10 repeats Figure 8, but with several features highlighted. Symmetry can be a powerful assistant in the interpretation of single SIDER results. For example, features marked "3" show symmetry. These features are coincident with deck penetrations (deck prisms). Features 4 and 5 appear to be almost symmetric, but they are not quite symmetric. Feature 4 maps to a deck prism that only exists on the port side. Feature 5 maps to a deck vent that is only on the starboard side.

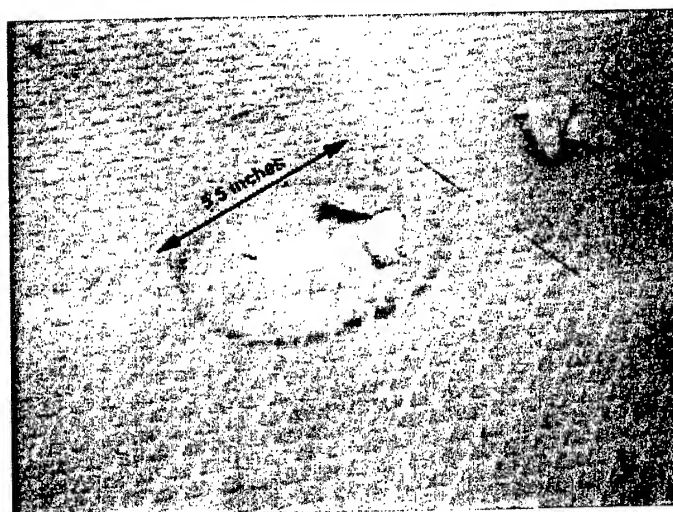
**Figure 11. Damage to Nonskid Surface**
